**STILL BOTTOMS POND AREA FINAL ENGINEERED COVER
CONSTRUCTION COMPLETION REPORT**

**AMERICAN CHEMICAL SERVICE, INC.
NPL SITE
GRIFFITH, INDIANA**

MWH File No. 2090601

April 2005

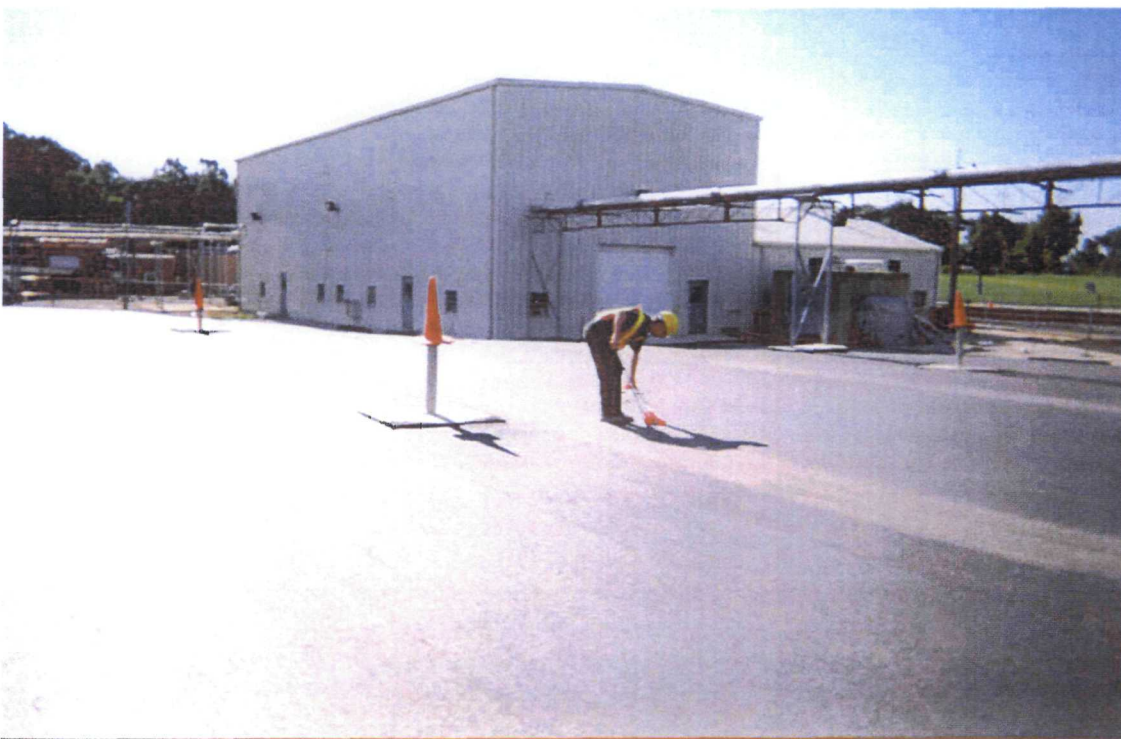
Photo 34

Independent QC
contractor marking
test grid onto
pavement

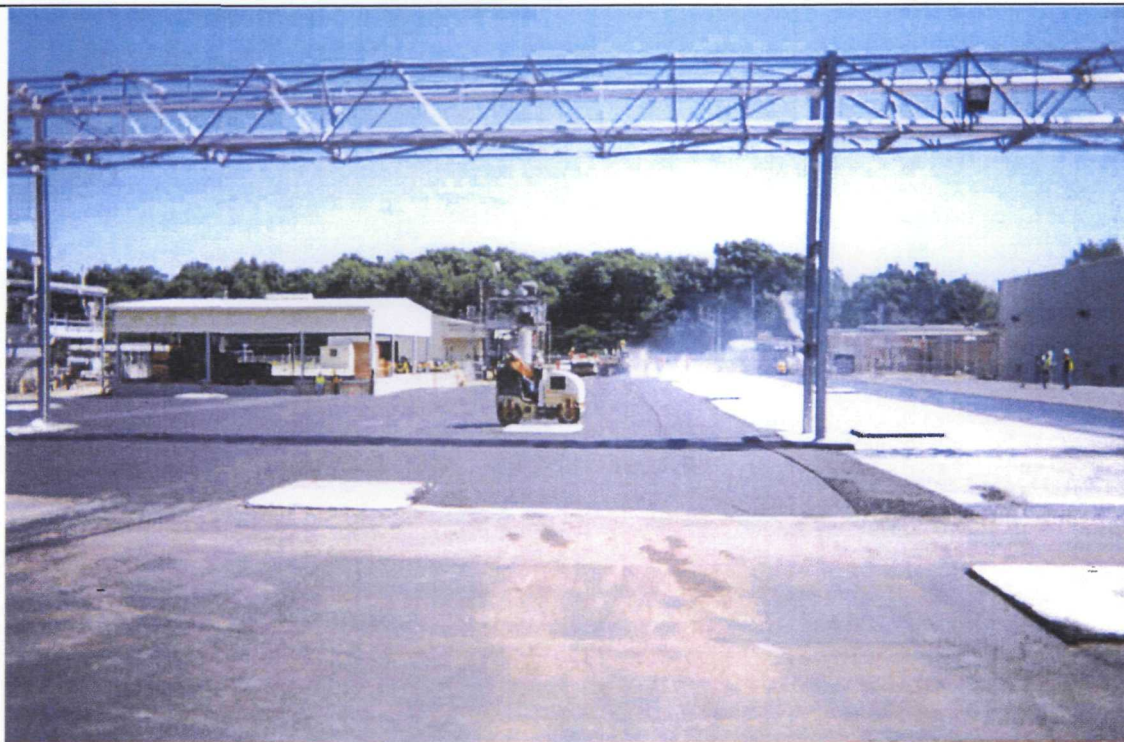
Photo 37

Nearing completion of asphalt cover

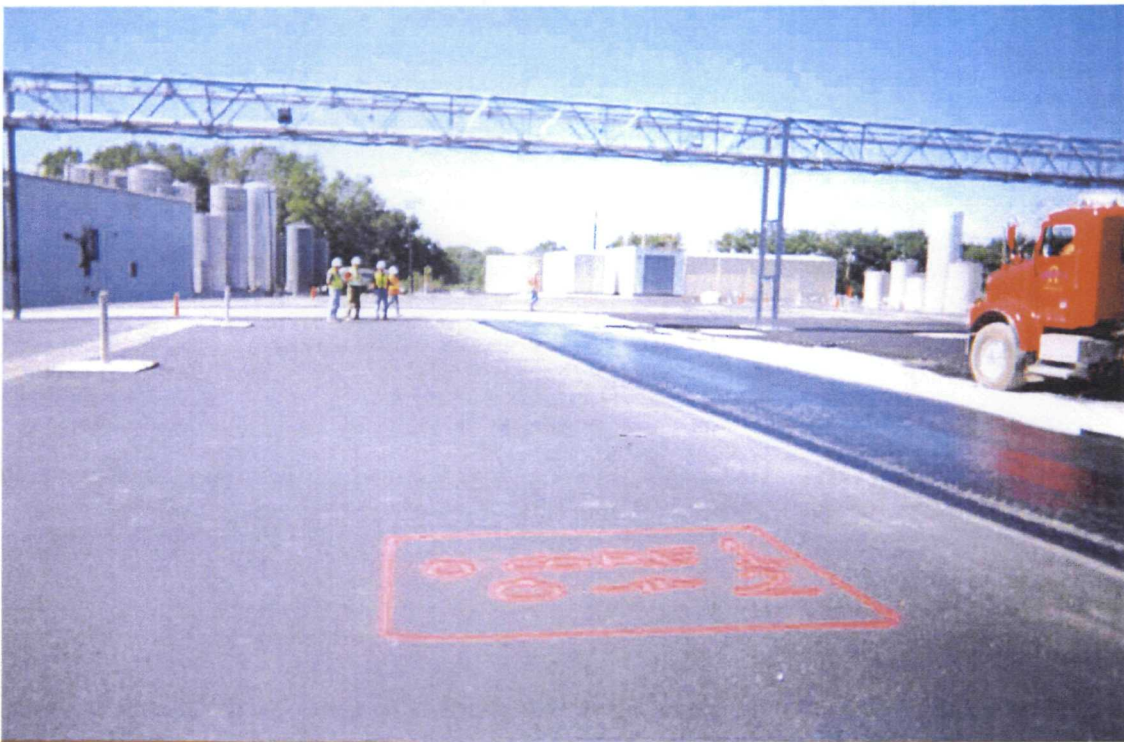
Photo 38

Markings made on final cover for areas to be core sampled
